2001 Annual Compliance Report Shiprock, New Mexico, Disposal Site

Figure 16-1. 2001 Compliance Drawing for the Shiprock, New Mexico, Disposal Site

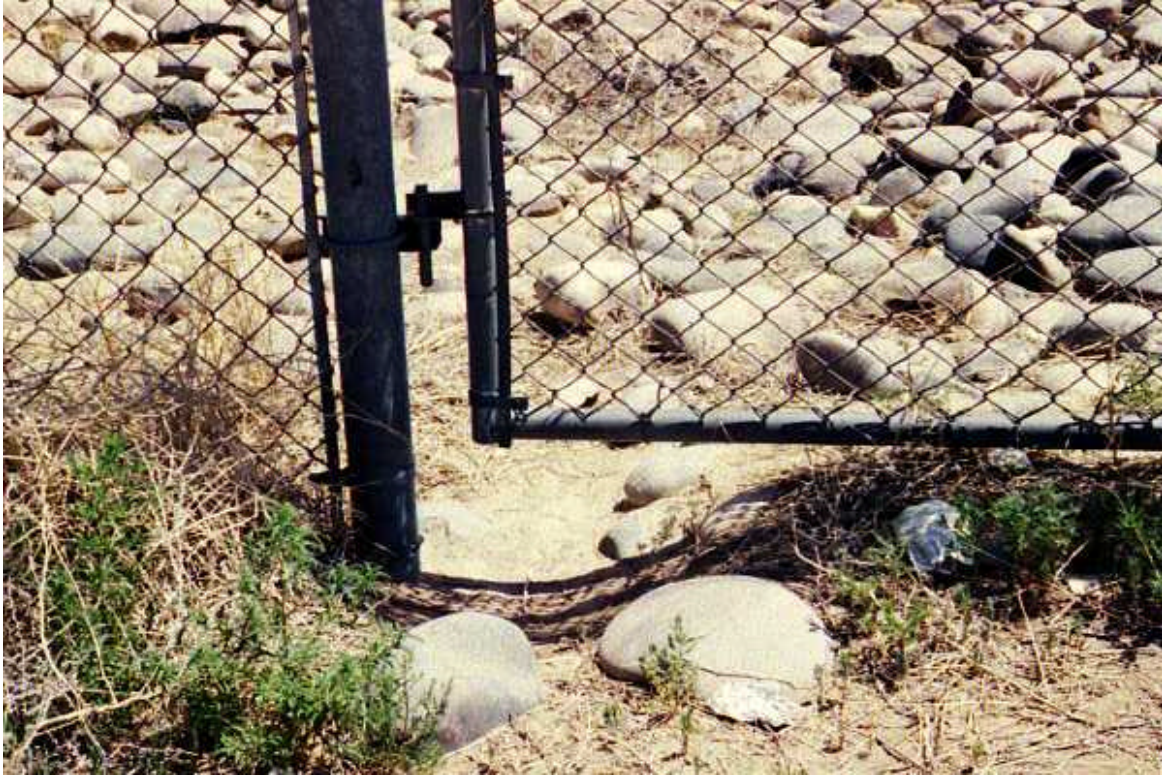
Inspectors noted several locations around the perimeter fence where animals (most likely dogs and coyotes) have crawled beneath the chain link fence fabric or underneath the access gates (PL-1). The openings are sufficiently large to allow access by a small child. Although there is currently no evidence of unauthorized trespass, future inspections should continue to monitor these potential access points for signs of human entry.

PL-1. Potential Site Entry Point beneath the Access Gate
